NASA CR-54323  
EOS REPORT 4920-Final

# ION ROCKET SYSTEM RESEARCH AND DEVELOPMENT

NATIONAL AERONAUTICS AND SPACE ADMINISTRATION

**ELECTRO-OPTICAL SYSTEMS, INC.,** Pasadena, California  
A Subsidiary of Xerox Corporation

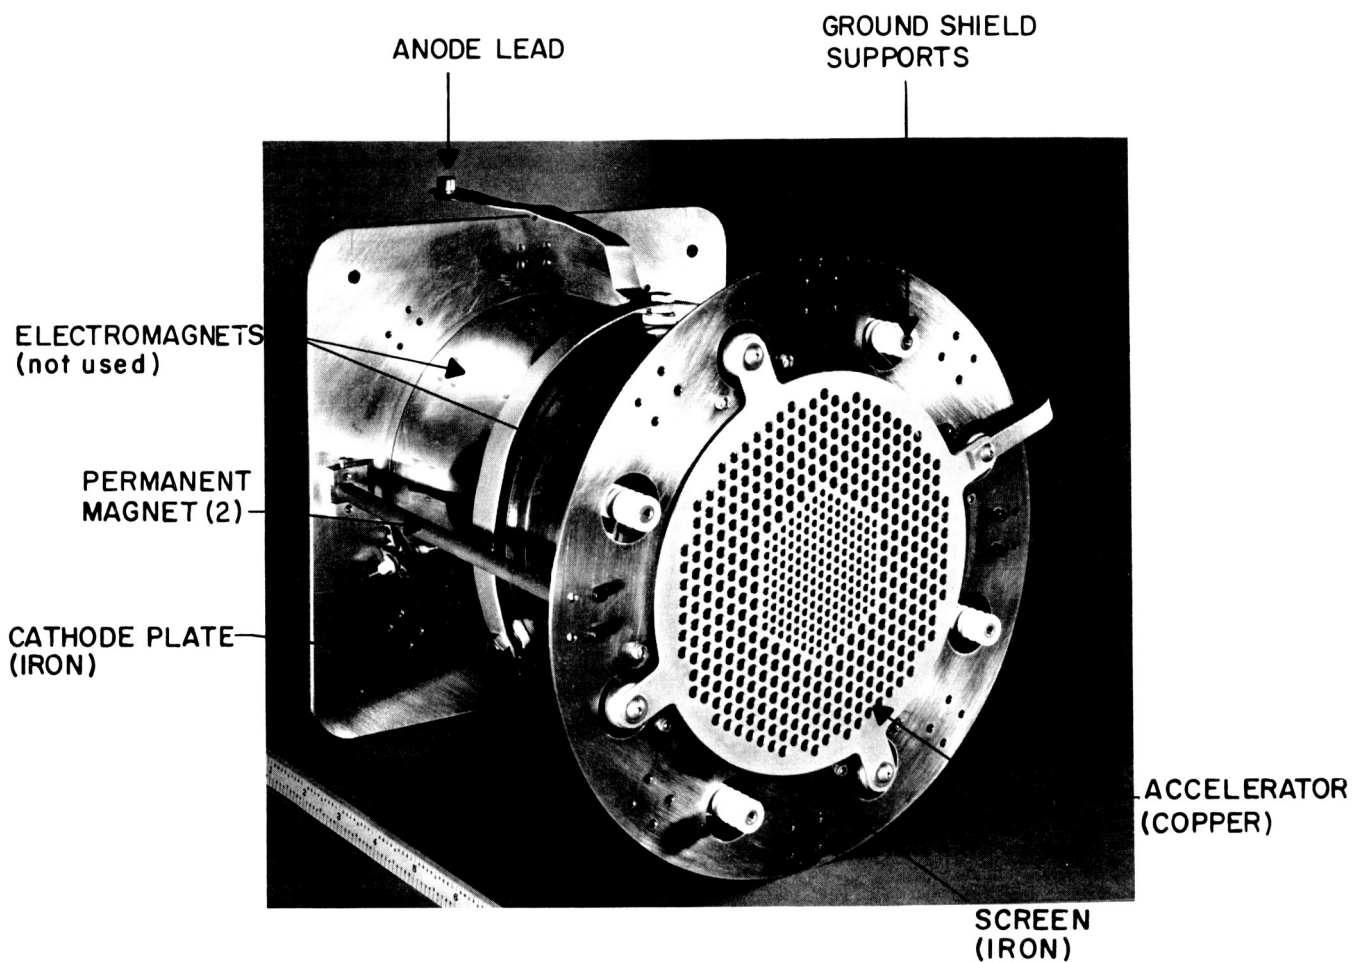
FIG. 119 DE ENGINE WITH PERMANENT MAGNET MODIFICATION

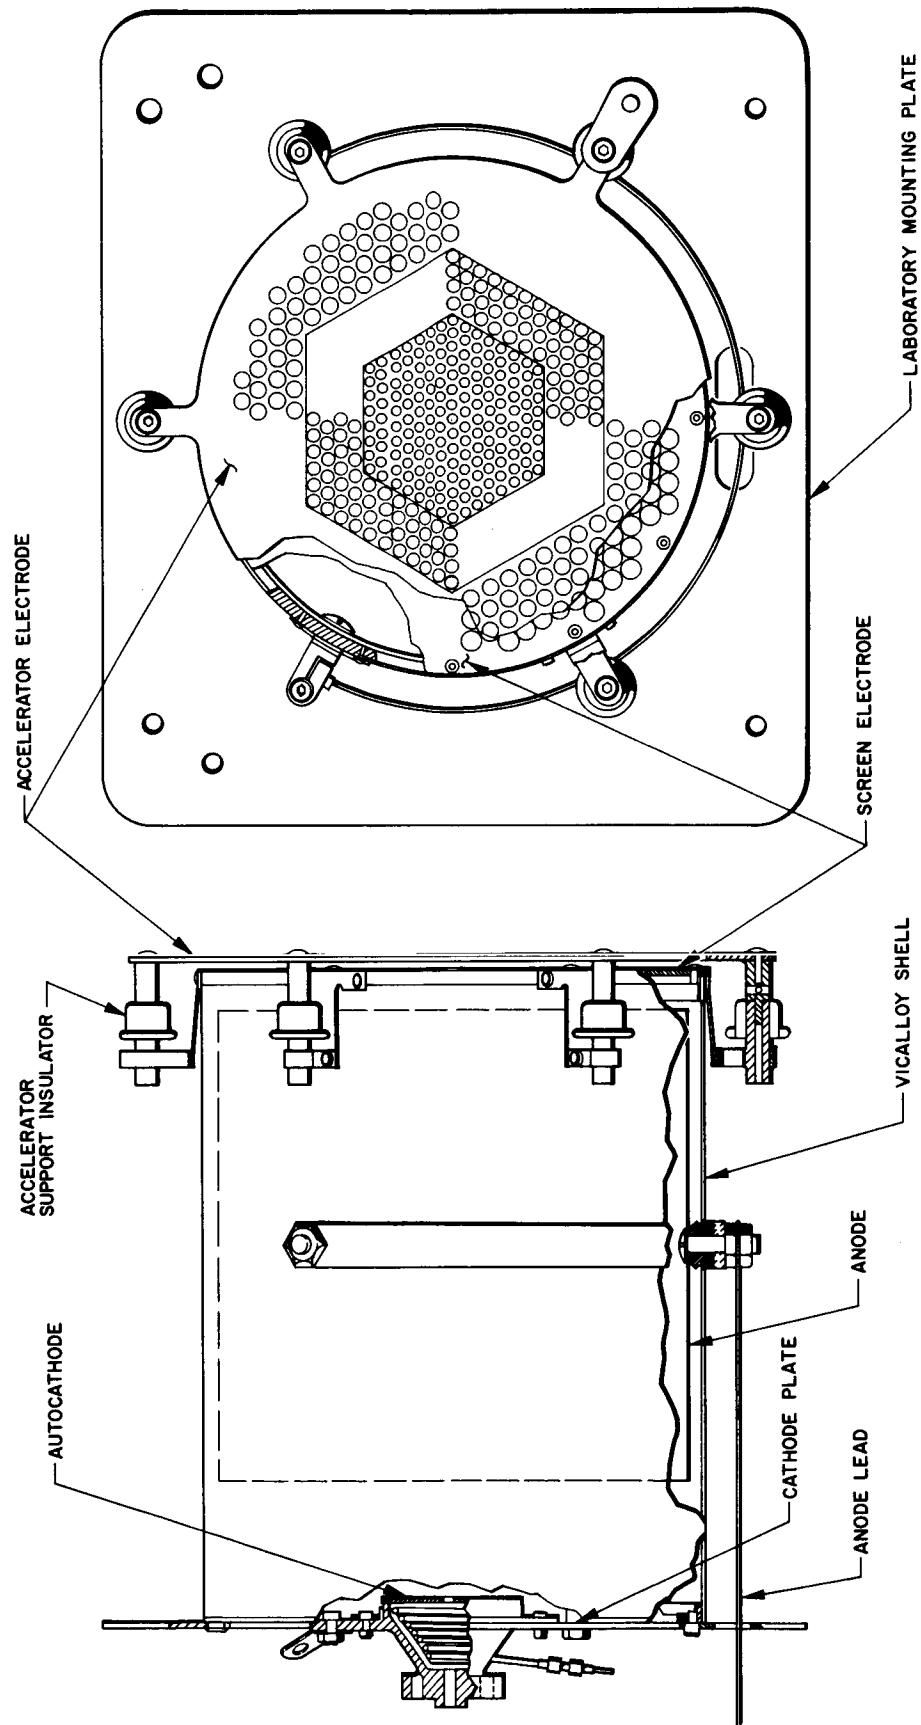
FIG. 120 PERMANENT MAGNET ENGINE DESIGN

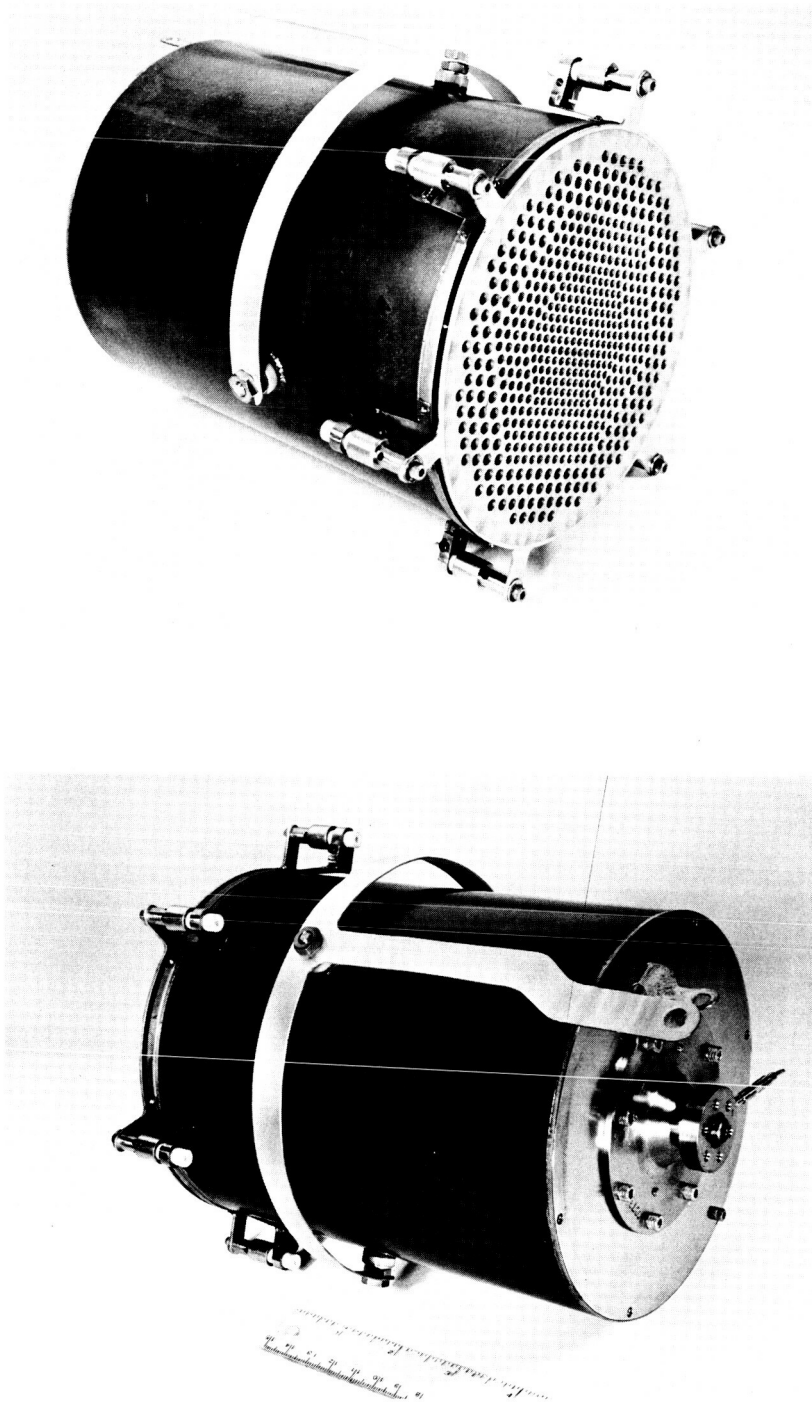
FIG. 121 PERMANENT MAGNET ENGINE

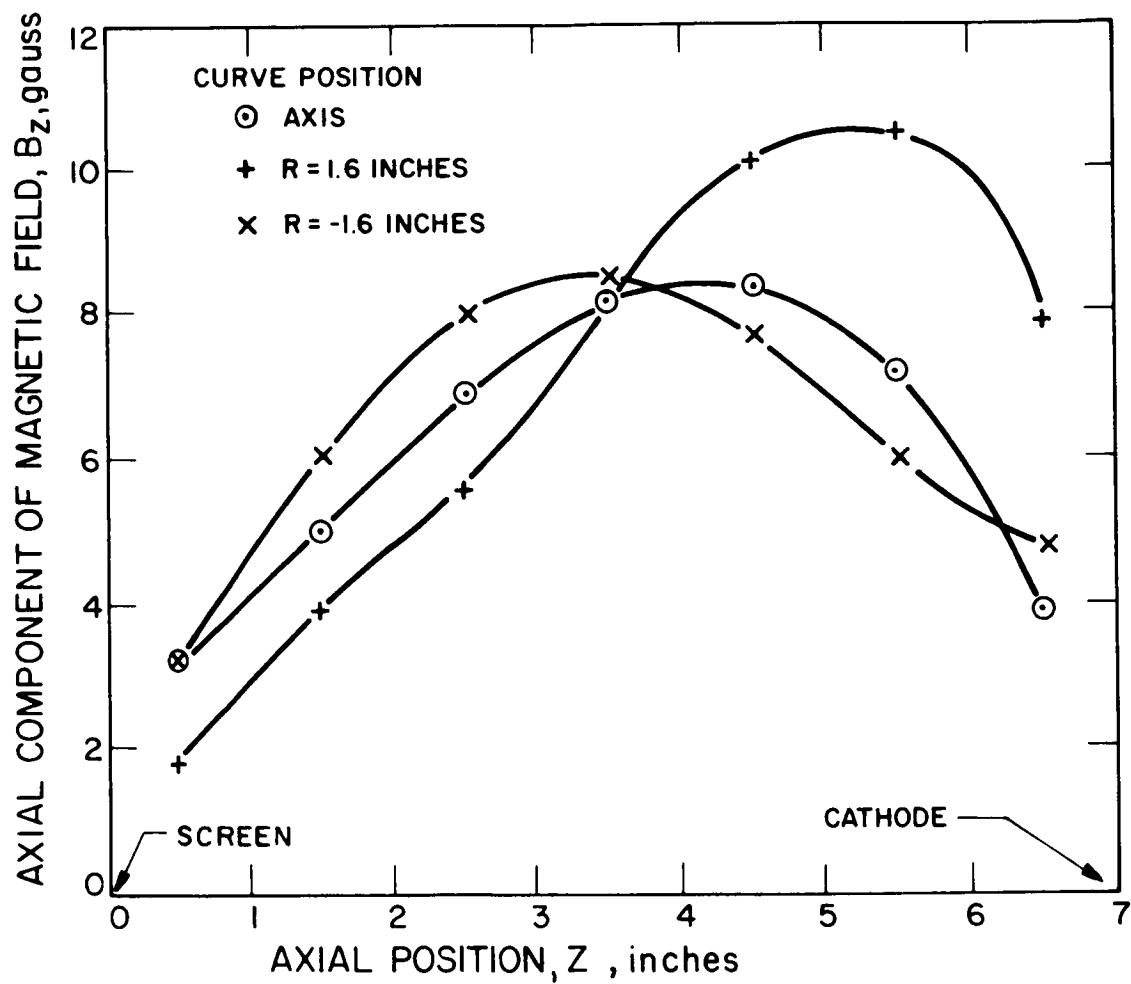
FIG. 122 PERMANENT MAGNET ENGINE MAGNETIC FIELD

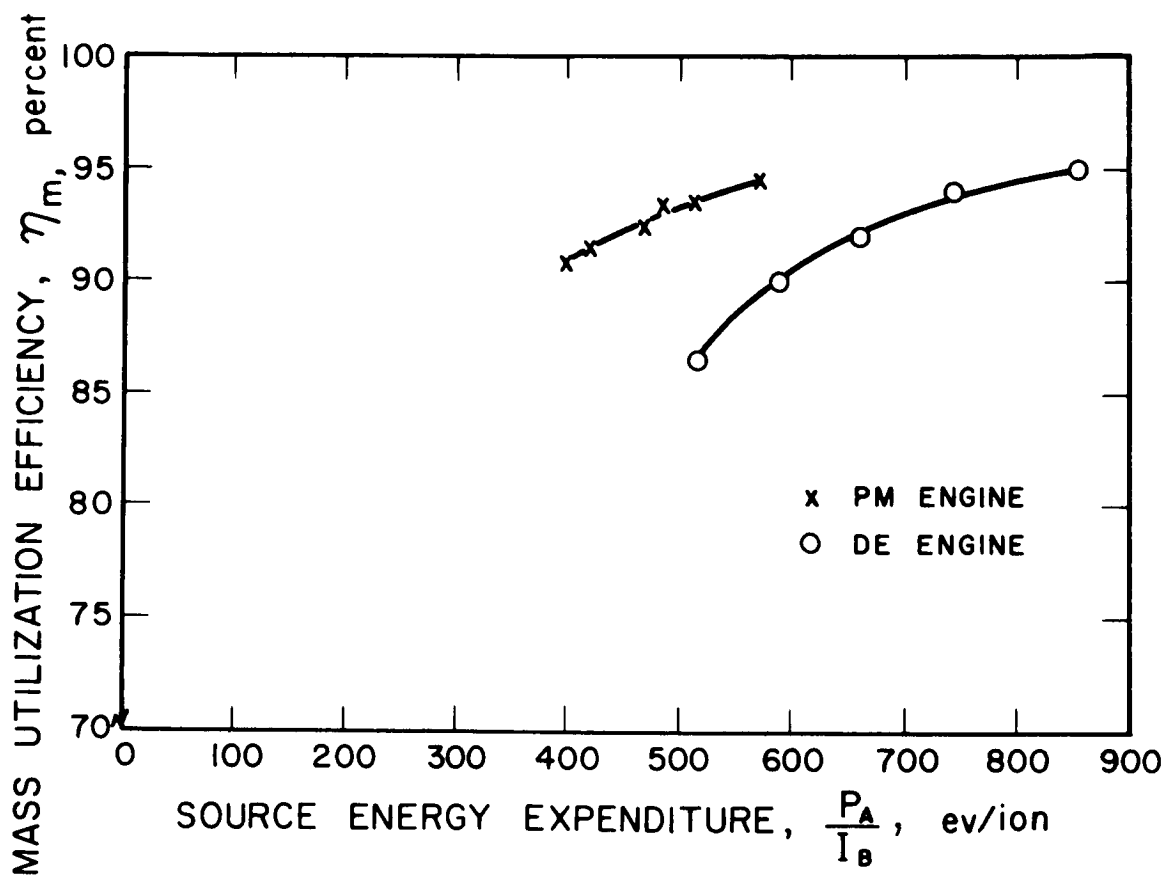
FIG. 123 MASS UTILIZATION EFFICIENCIES OF PM-1 AND DE ENGINES

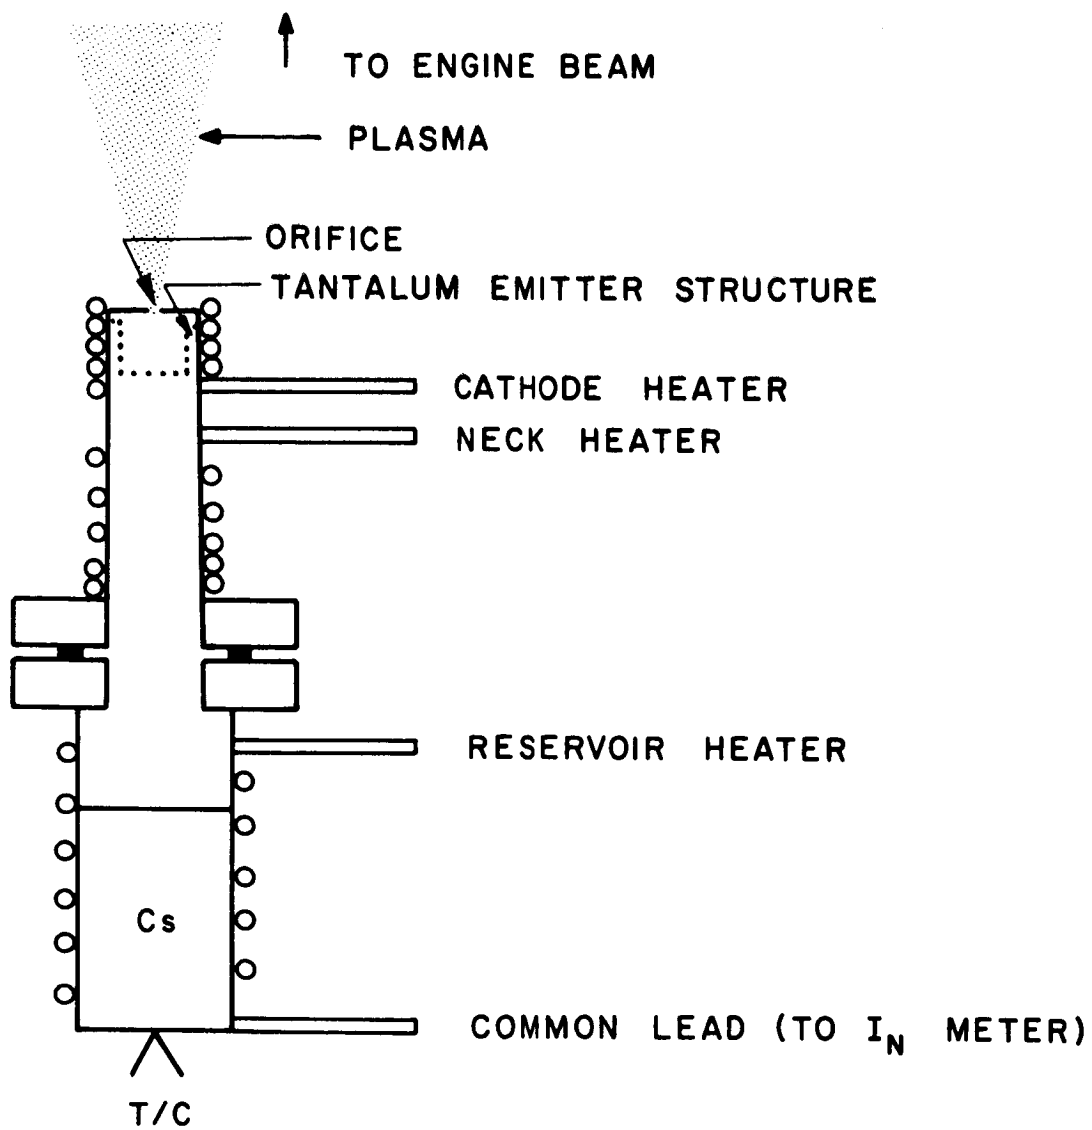
FIG. 126 SCHEMATIC OF PLASMA BRIDGE NEUTRALIZER

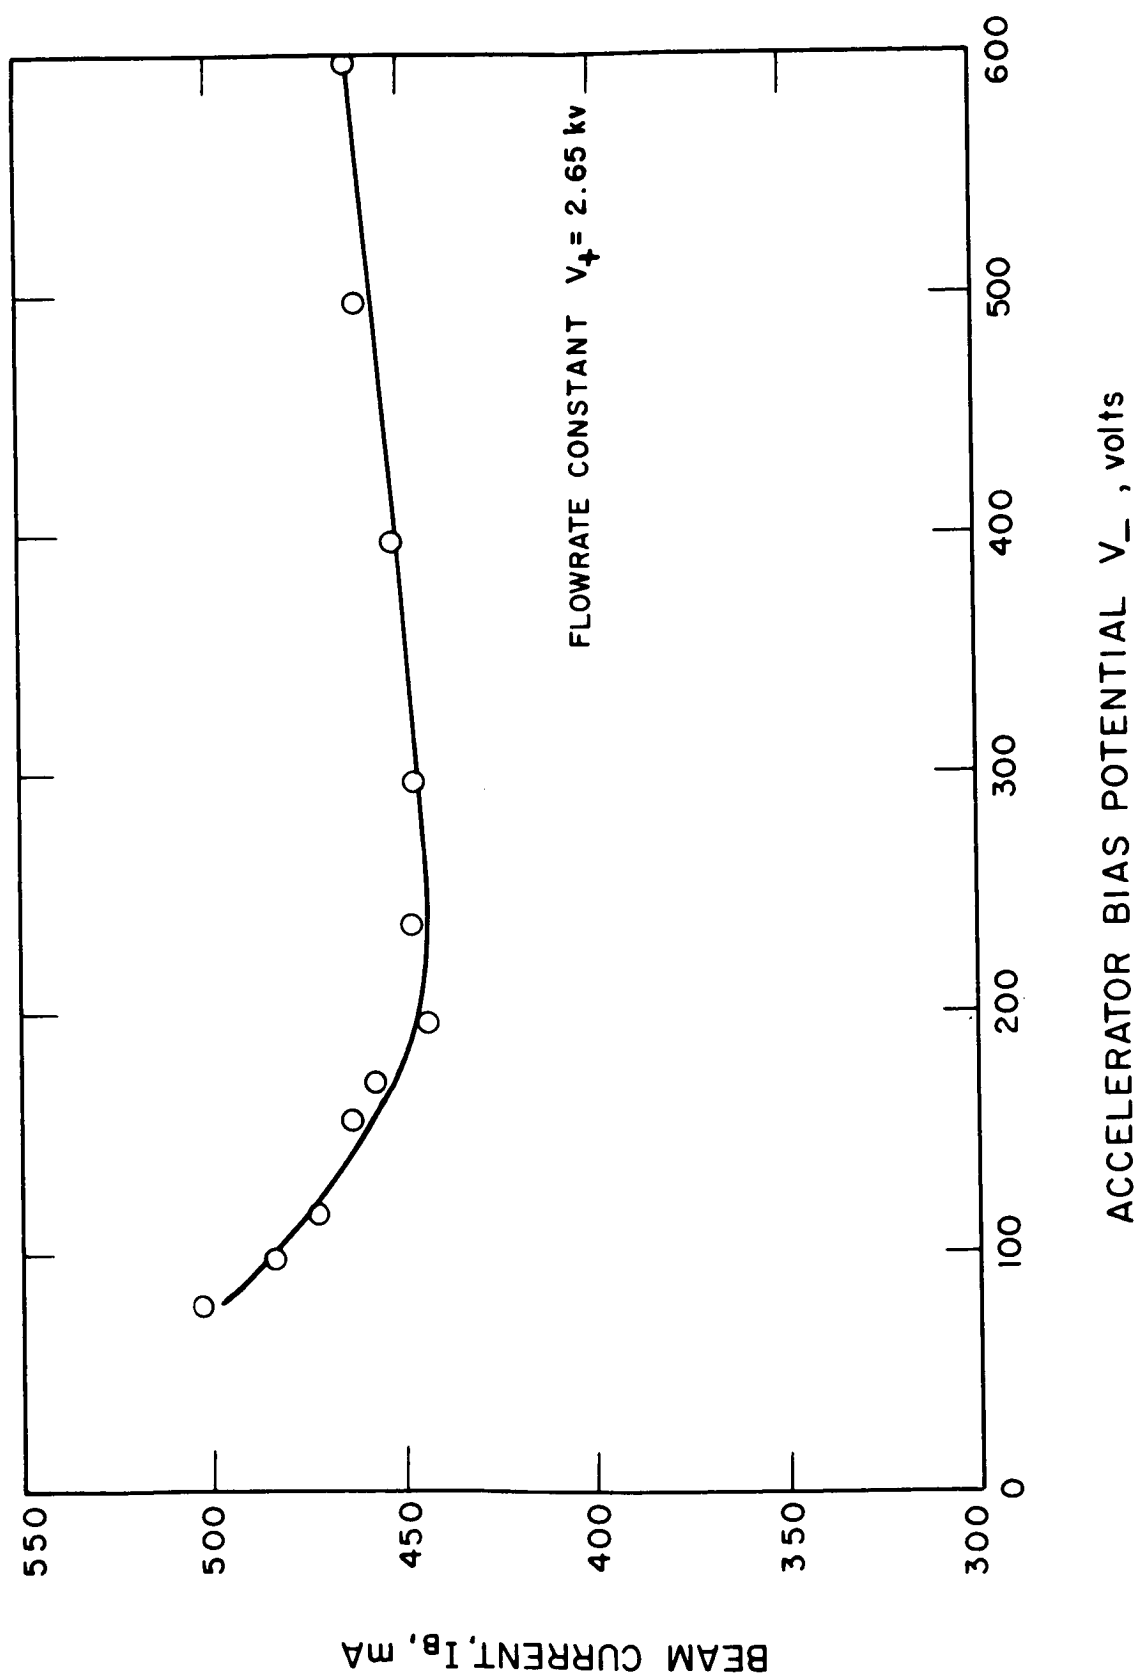
FIG. 128 BEAM CURRENT VERSUS ACCELERATOR BIAS
